DEFENDANTS' MOTION FOR SUMMARY JUDGMENT—EXHIBIT 1  
WILLIAM CARDEN EXPERT REPORT (JAN. 24, 2018)

## Materials Engineering Report

Reference: Clarence Edward Whitaker, etc. v.  
Hyundai Motor Company, et al.

Subject Vehicle: 2007 Hyundai Santa Fe,  
VIN 5NMSH13E57H041555

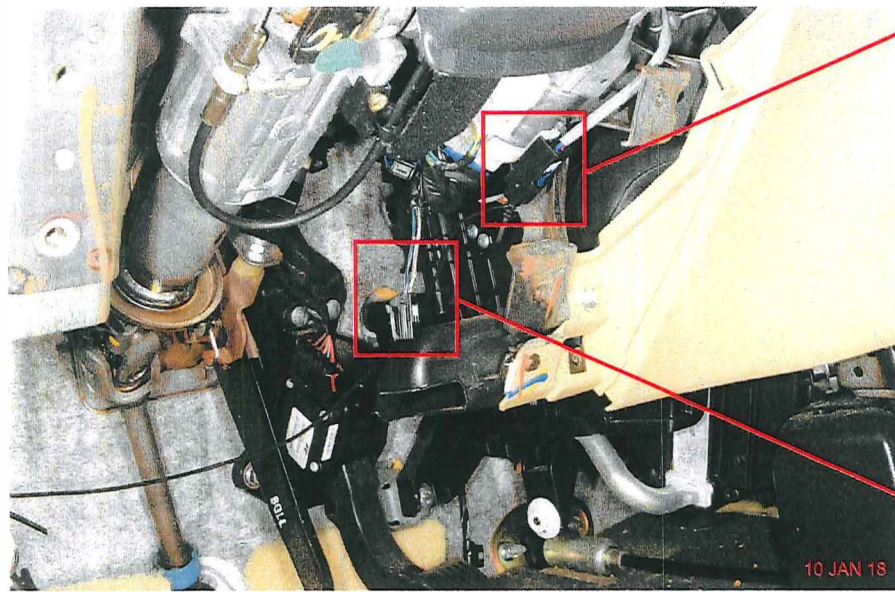
10 JAN 18  
DP-0421

Further observation of the subject 2007 Hyundai Santa Fe, VIN 5NMSH13E57H041555, revealed that an ignition lock solenoid connector that is a part of the shift interlock system was not connected. With the battery connected to the vehicle, the voltage across the connectors was measured. With the transmission gear shift selector in the PARK position, the voltage meter measured 0.0 volts. With the transmission gear shift selector biased out of the PARK position, the voltage meter measured 11.2 volts. Further evaluation was suspended until the vehicle could be transported to a laboratory for detailed examination of the vehicle components.

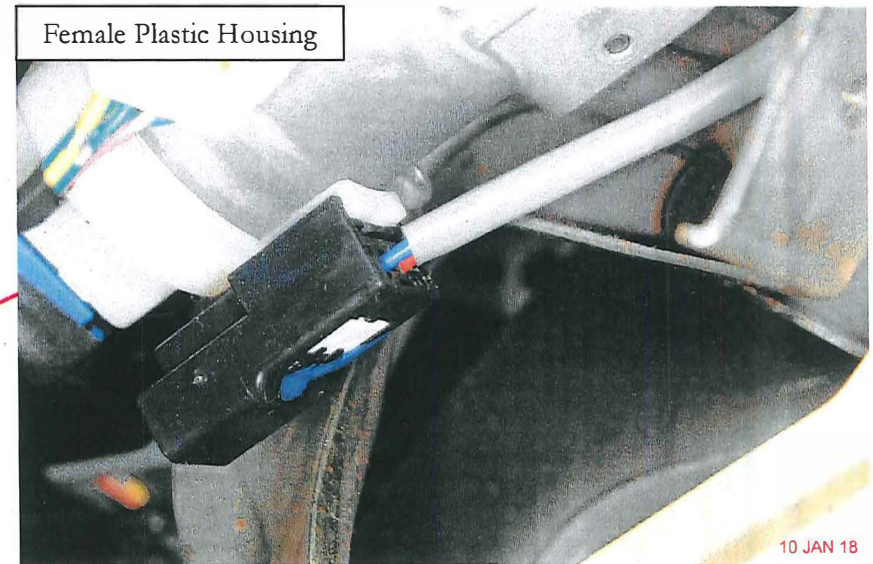
10 JAN 18  
DP-0425

Female Plastic Housing

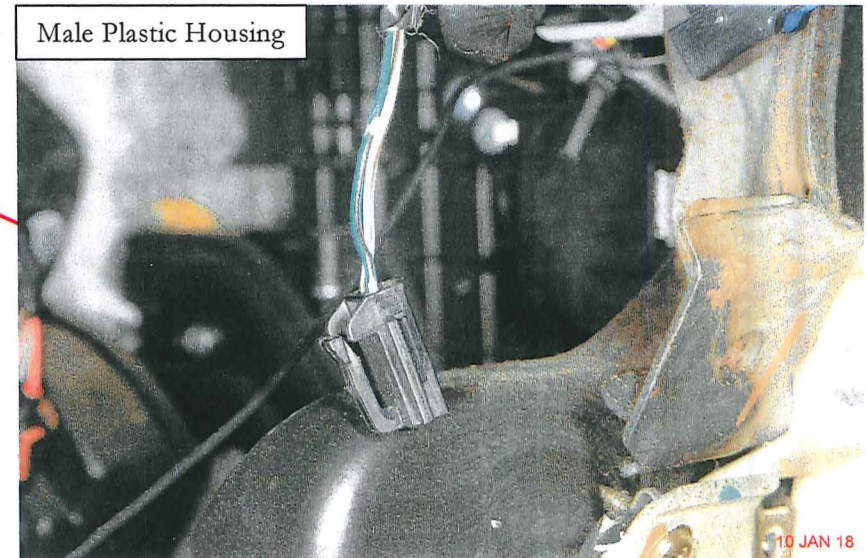
10 JAN 18  
DP-0426

The subject male connector housing had a locking lever arm that engaged the mating side holding it in place by a barb feature, as shown in Enclosure 13. Scratches and a gouge were observed on the surface in front of this lock feature. The molding seam adjacent to these features was still raised above the surface of the housing, as shown in Enclosure 14. The lock feature was intact and undamaged. The partial engagement of the connector allows the electrical continuity between the wiring, yet the connector can be separated without depressing the lock feature.

Male Plastic Housing

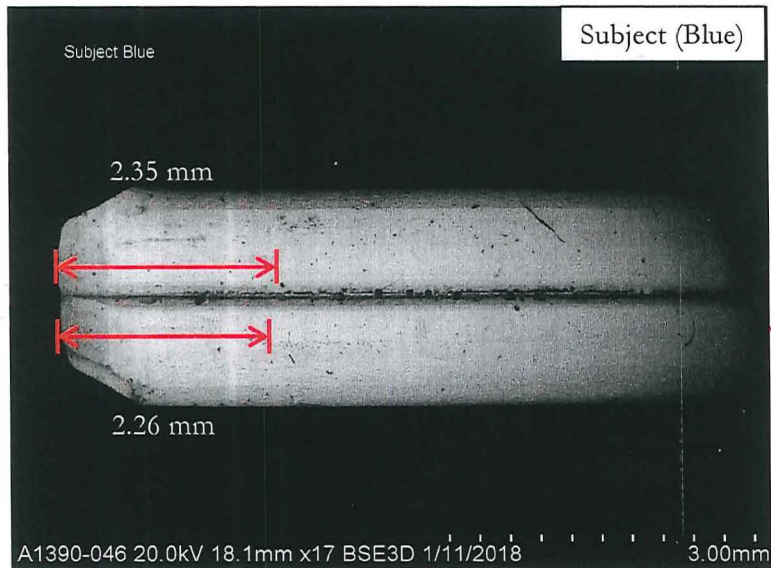
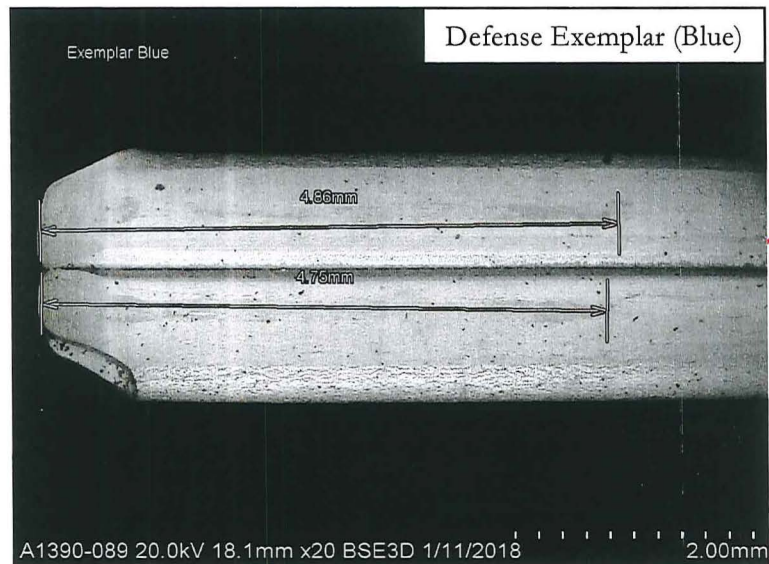
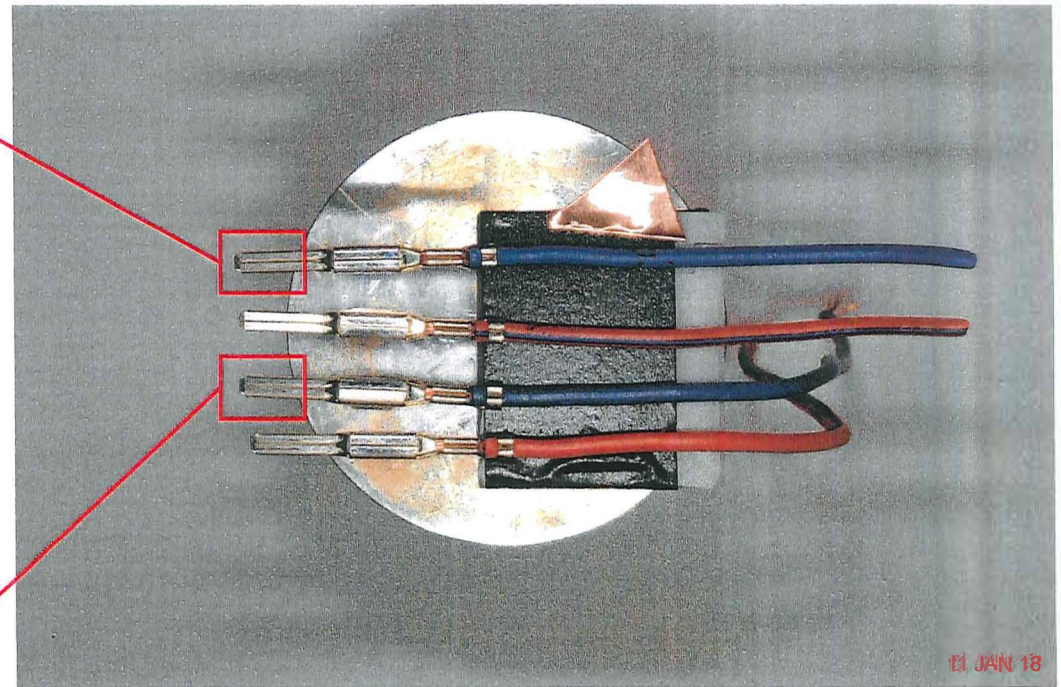
DP-0851

The contact areas on the subject blades were examined, documented and measured. Comparison with exemplar connectors in corresponding locations revealed that the contact areas on the subject connector blades were approximately 2.4 mm shorter, as shown in Enclosures 6 through 9. Exemplar examinations, analysis of CT data, and comparison with the subject connector indicate that the subject connector was not fully engaged in its locked position at the time the subject vehicle was manufactured, as shown in Enclosures 10 through 12.

Clarence Edward Whitaker, etc. v. Hyundai Motor Company, et al.  
Subject and Exemplar Ignition Lock Solenoid Connector Blades

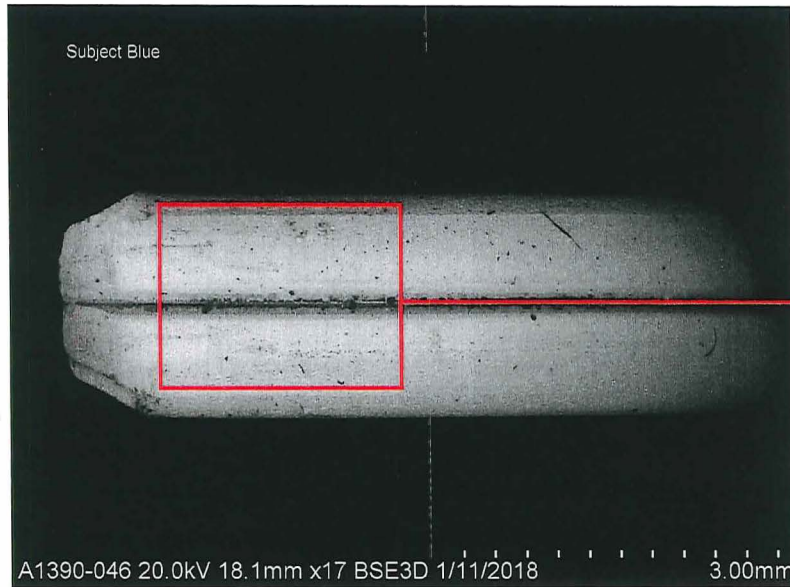
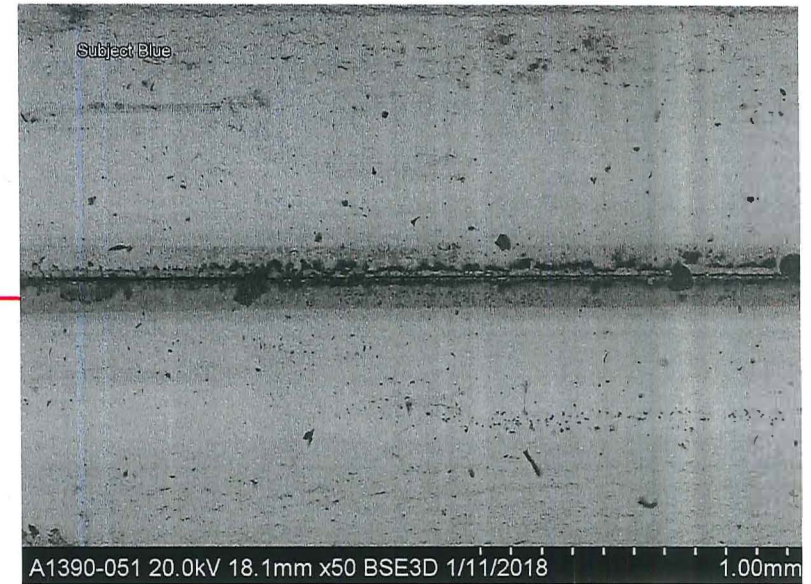
Subject  
Connector Blade  
(Blue)

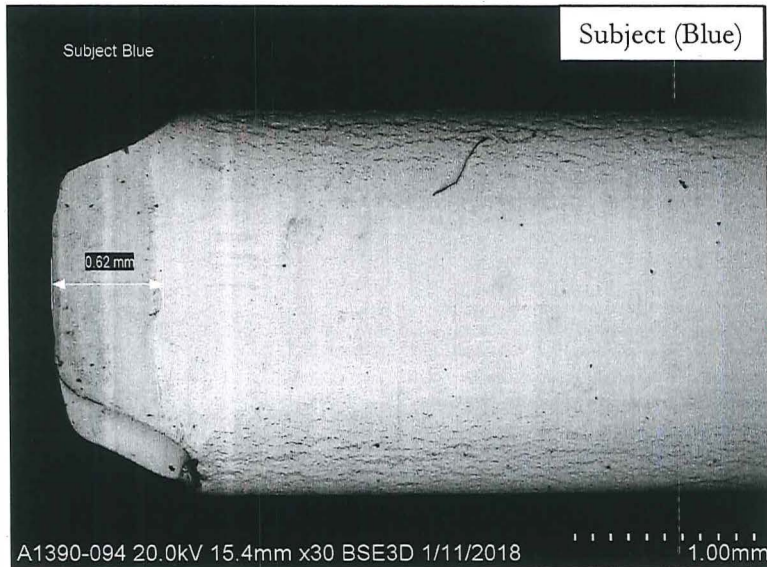
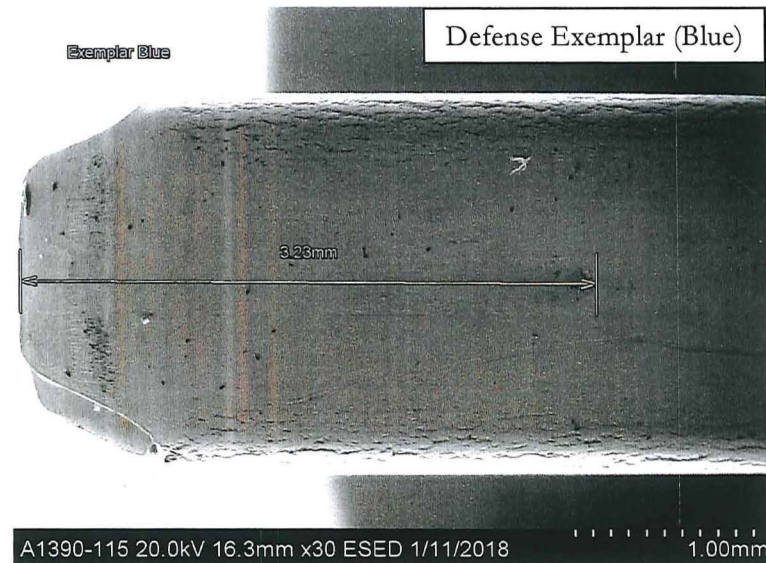
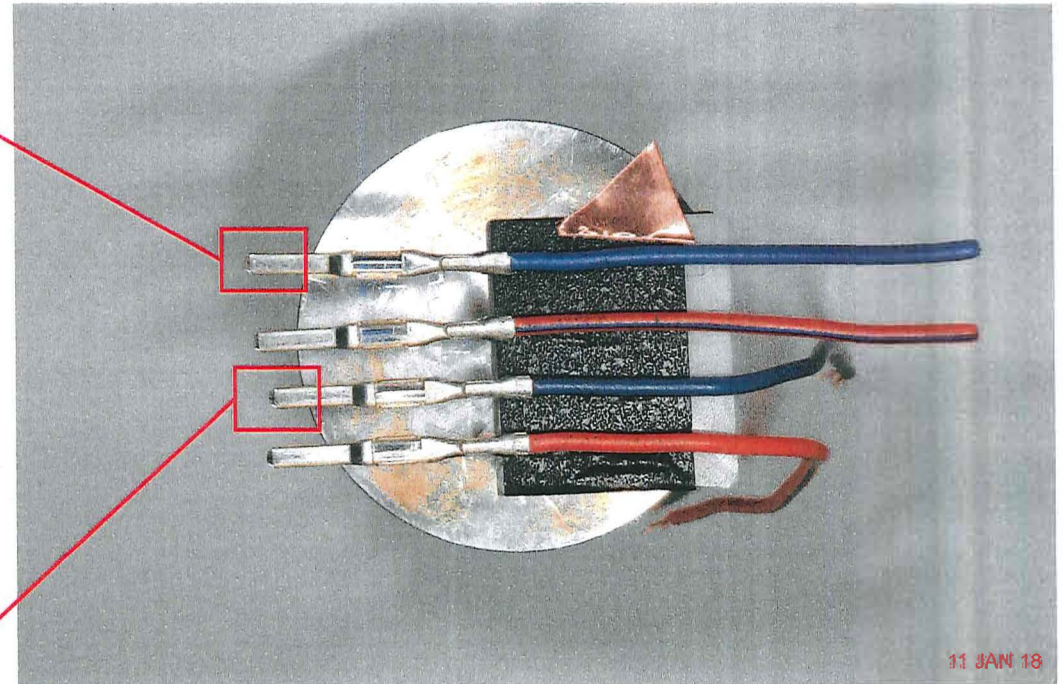
DP-0917

Clarence Edward Whitaker, etc. v. Hyundai Motor Company, et al.  
Subject and Exemplar Ignition Lock Solenoid Connector Blades – Other Side

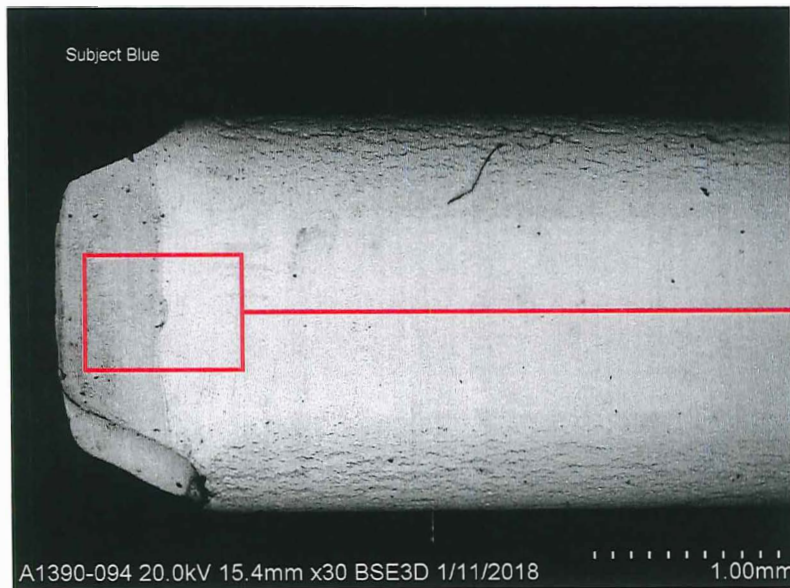
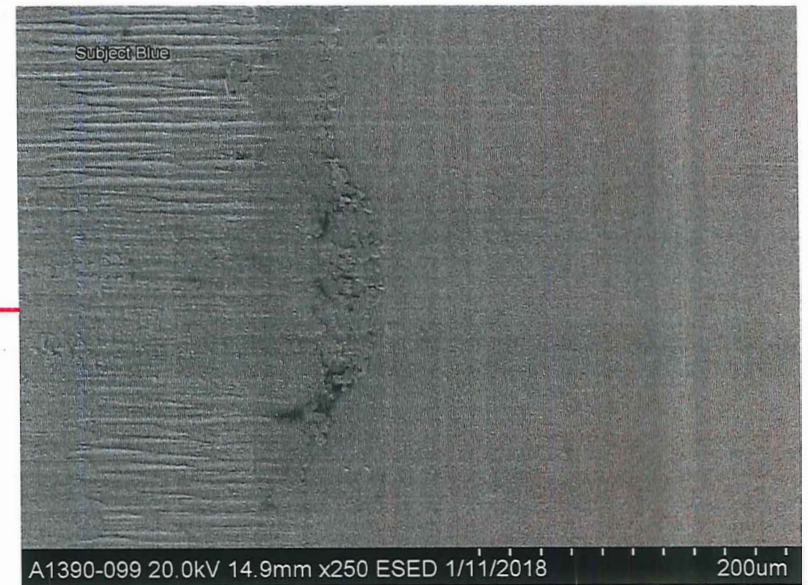
Subject  
Connector Blade  
(Blue)

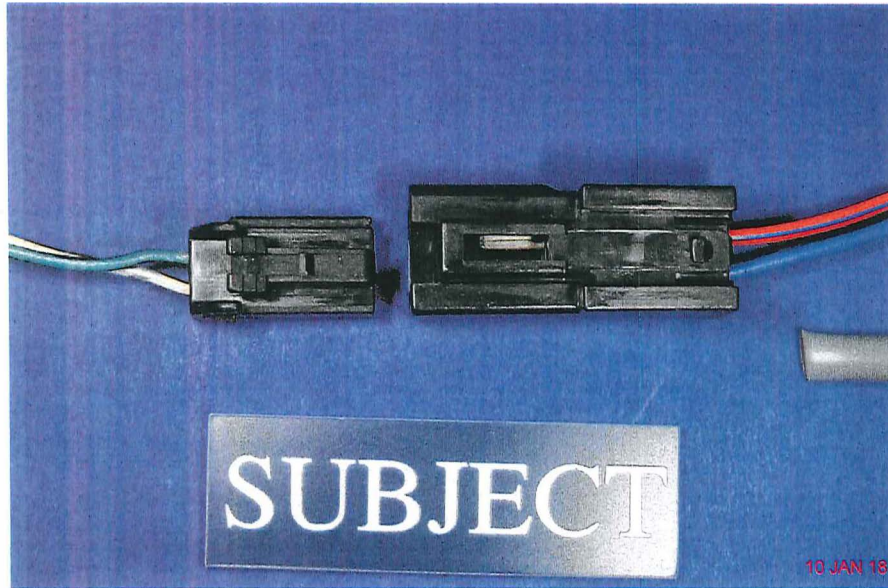
DP-0468

Subject Connector

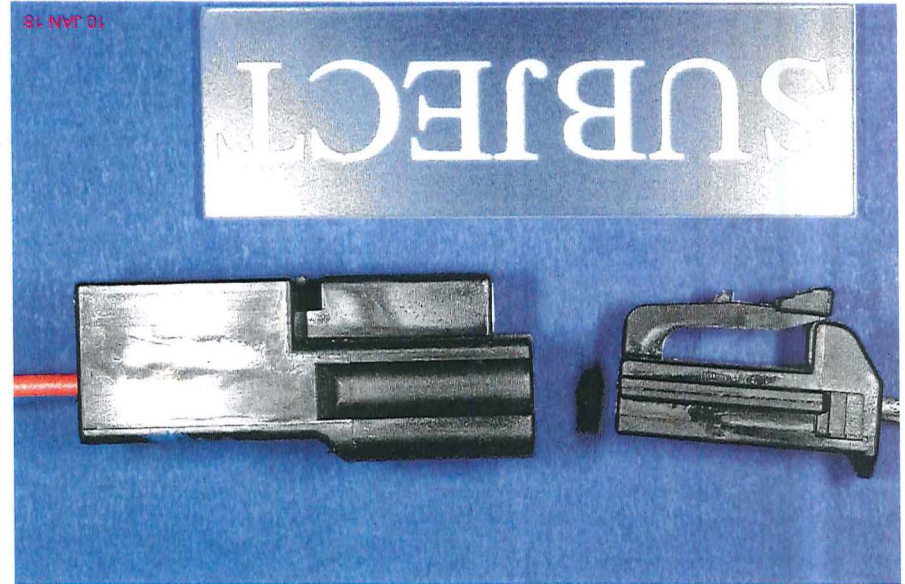
DP-0484\_rotated

Subject Connector

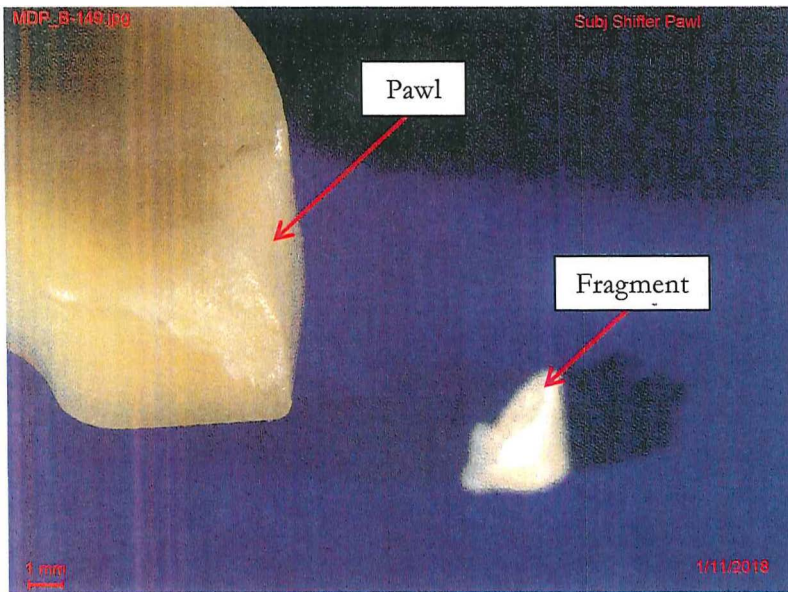
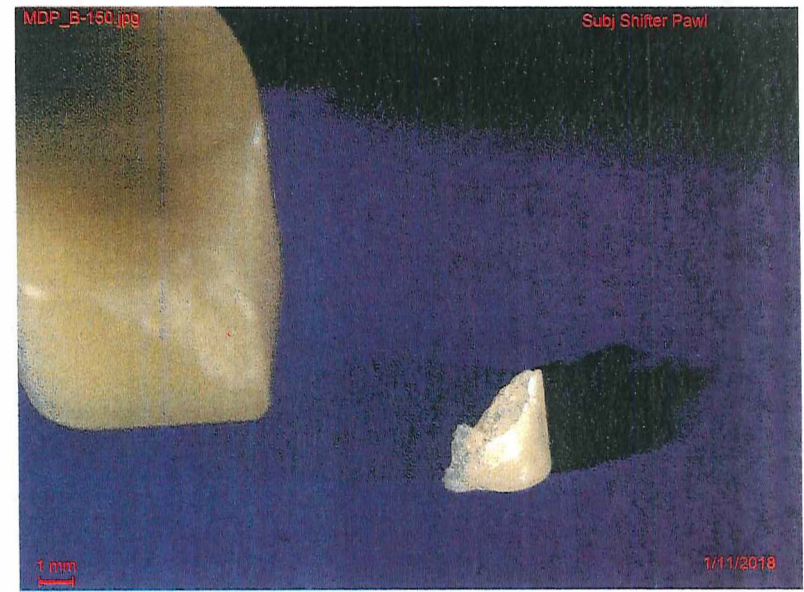
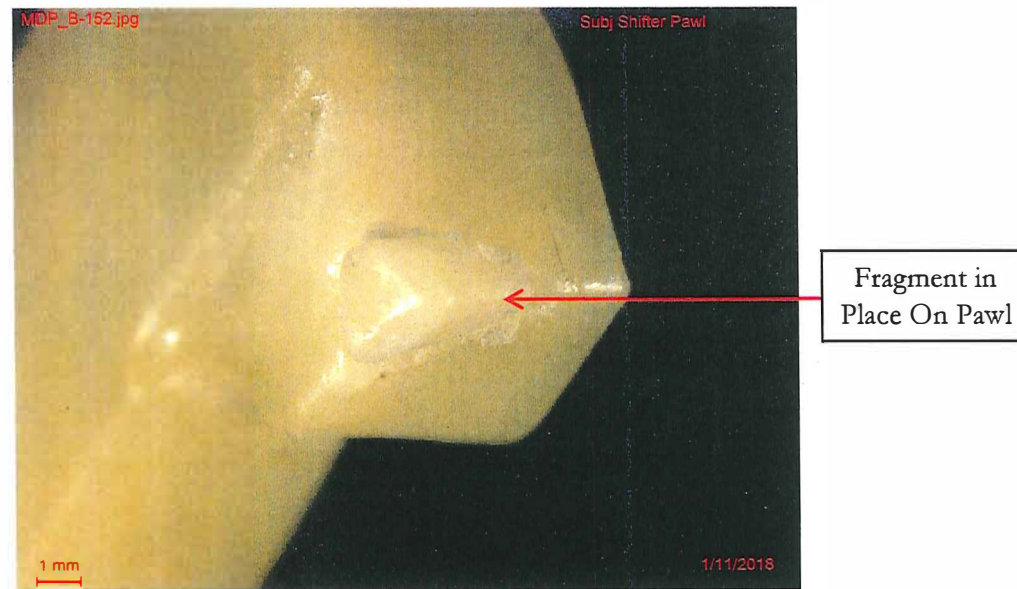
FTIR, SEM, and X-ray spectroscopy examination of the pawl revealed it to be constructed of glass fiber reinforced Nylon 6,6. Examination of the subject shift lever locking pawl revealed that the corner of the pawl that contacts the shift lever assembly was broken off. A small polymer fragment was observed and retrieved from the floor of the subject vehicle directly below the shifter, after the shifter was removed from the vehicle. This fragment was retrieved for further examination, as shown in Enclosure 16.

same size and shape of the missing corner of the subject locking pawl. Chemical and SEM analyses of the fragment revealed that it is made of glass fiber reinforced Nylon 6,6, the same as the locking pawl. This confirmed that the fragment was the missing piece of the locking pawl.

The stereomicroscopic and SEM examination on the fracture surface of the fragment revealed that it fractured in overload. Deformation and surface buckling adjacent to the fracture observed on the locking pawl is also consistent with overload fracture of the locking pawl.

The broken corner of the locking pawl allows the shifter to be shifted out of PARK without the brake being depressed. This renders the locking functionality of the pawl to be ineffective.

Subject Fragment Retrieved Below Shifter
